"Electrifying Oil by Over-Filtration in Gas Turbines"

Author: Greg J. Livingstone, Clarus Technologies

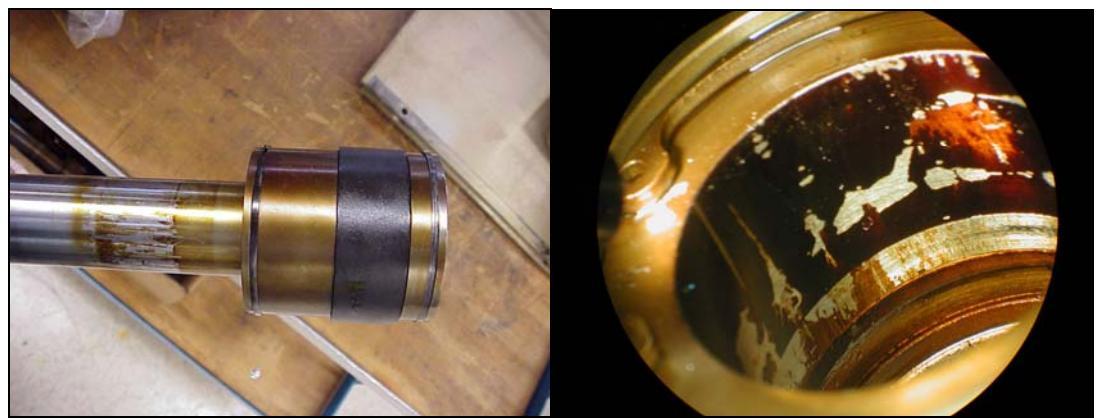
A merchant plant, located in Texas consists of a series of combined cycle gas turbines generating a total of 1,000 MW in electrical capacity. The turbine generators cycle operation daily and have been in operation for about 4 years. After two years of service, erratic performance began in the fuel gas valves and IGV (Inlet Guide Vane) positioners. Inspection of the valves indicated a brown tar-like coating – varnish.

Figure 1&2: Varnish Coating on Inlet Guide Vane (IGV) Servo Valve

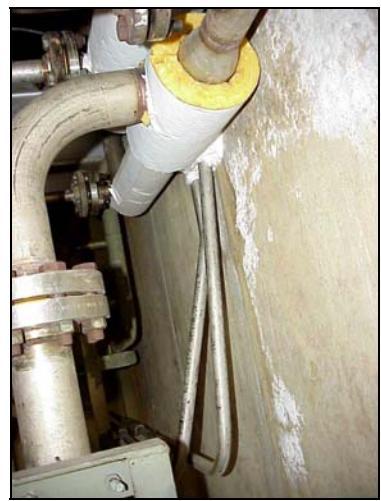
Figure 3: One potential source of heat from the fuel gas system was eliminated as a potential source of coking in the IGV hydraulic lines by insulating the lines in the proximity of the heated fuel gas lines.

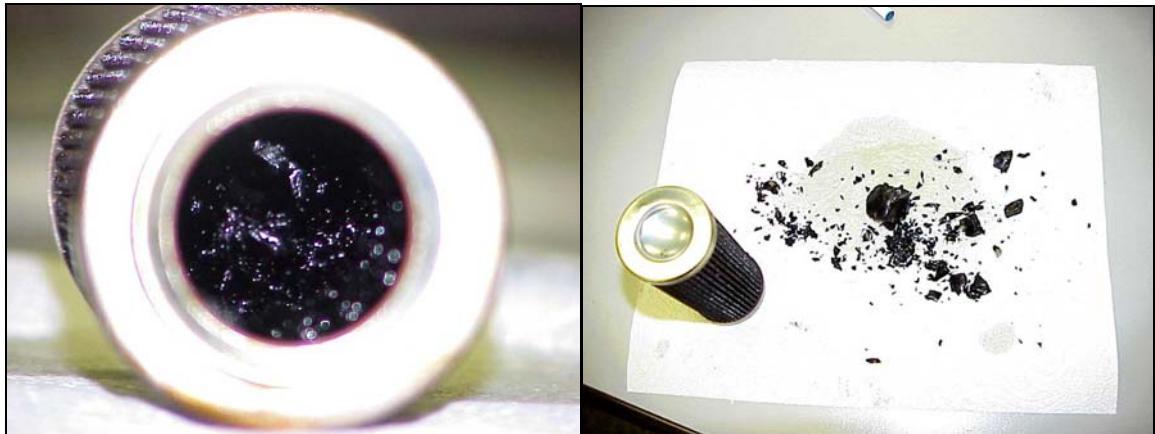
Three months later, a problem developed with IGV servo tracking, prompting the plant to inspect the valve's last chance filter. Large, black, solid pieces, similar to shiny coal, had restricted the filter orifice stopping oil flow. These chunks had developed inside the outside-in flow filter. Needless to say, the original varnish problems in the IGV valve were not fixed, and other serious problems remain.

Fig. 4-5: Plugged IGV Valve Last Chance Filter

After significant research, the plant determined that these filter chunks are the result of spark discharges that occurred inside the filter. The potential energy for these sparks was actually developed upstream of the last chance filter, in the 2-micron filter. The potential energy was stored in the oil until it hit the jagged metal edges of the last chance filter where the energy was released in the form of a spark. This had the effect of cracking the hydrocarbon molecule and coking the oil.

As discussed in detail in this article, the system's mechanical filters were contributing to the IGV valve varnish problem, not helping it. The plant is investigating insulating the 2 micron hydraulic oil filters instead of grounding the filters to lower the amount of potential energy that can be generated. In addition, the plant is using Kleentek electrostatic oil cleaners to solve the varnish problem.

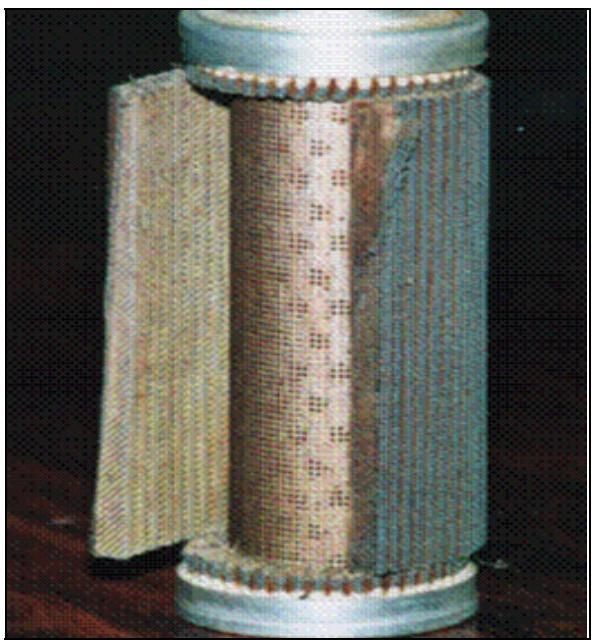
Figure 6: Single fingerprints are aligned on the filter core.¹

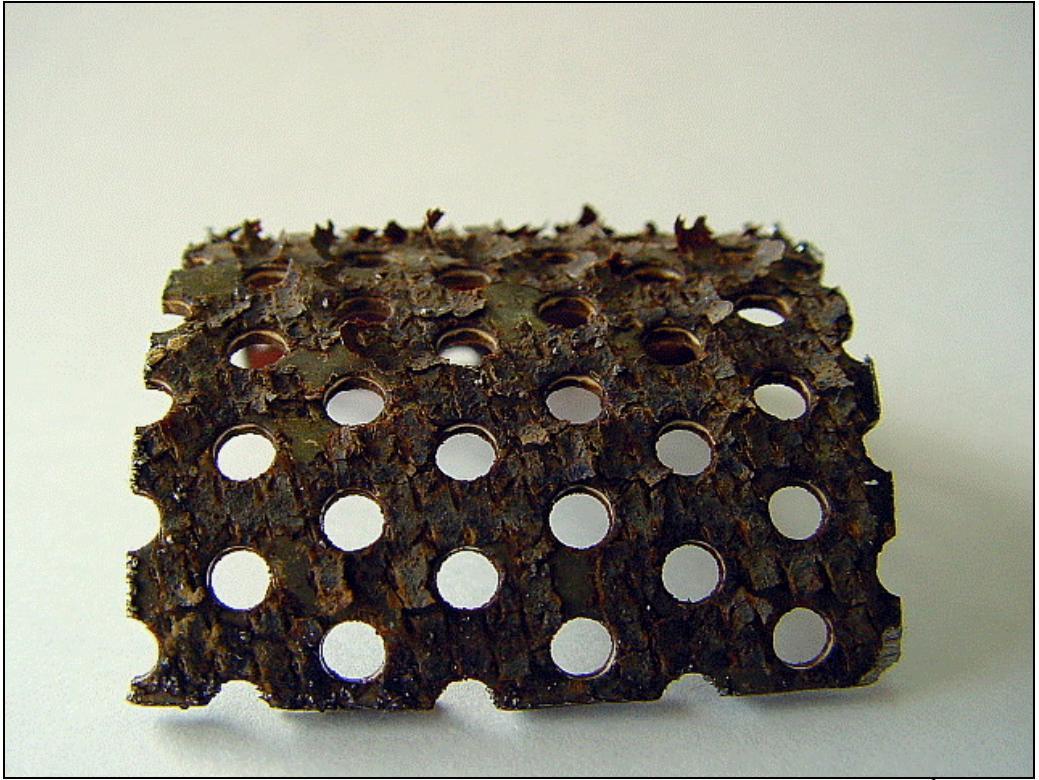
Figure 7: Flakes of coked oil found on the surface of filter core.¹

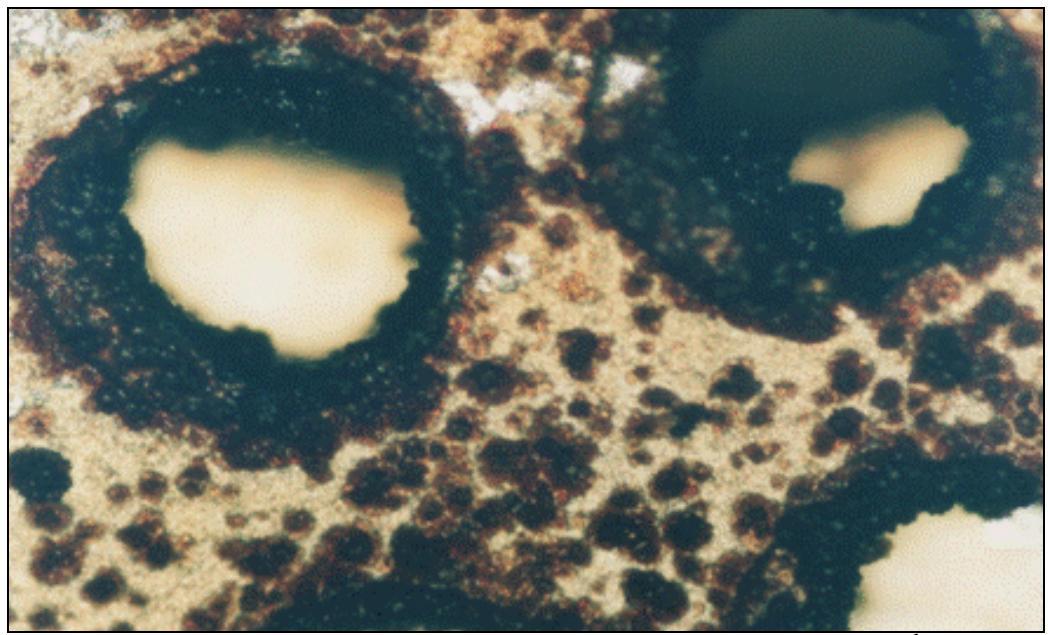
Magnification of the filter media will show several burned holes and is an excellent method to detect spark discharging in filters. An example of this is shown in Figure 8.

Figure 8: Magnification of filter media shows burned holes.¹
